Report on Accident that Occurred at Airport of Pristina "Adem Jashari" on 12 May 2015, involving a Helicopter Aerospatiale Puma SA330 J with registration EI-SAI, operated by Starlight Aviation

Investigation Report No:	ZKM KHAIA 004/ R
Type of Occurrence:	Accident
Date:	12 May 2015
Location:	Pristina International Airport Adem Jashari
Aircraft:	Rotary Wing Puma SA330 J Helicopter
Manufacturer / Model:	Airbus Helicopters / Serial no:1545
Registration:	EI-SAI
Injuries to Persons:	2 Minor injuries to rear crew
Damage:	Damaged beyond economic repair
Other Damage:	Impact damage to runway surface

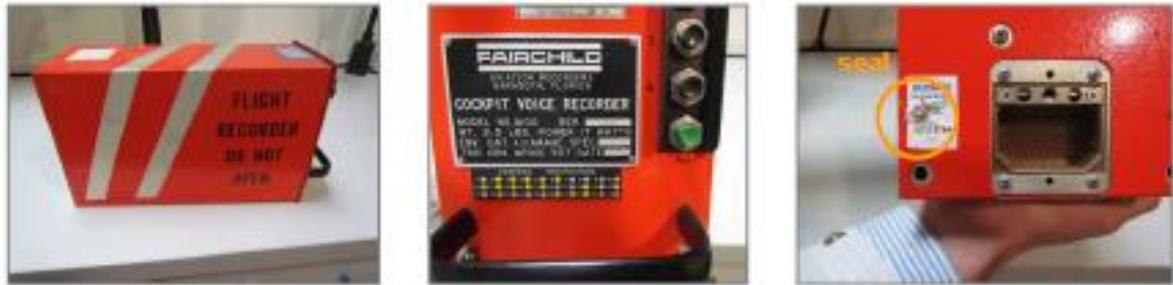
Image 2: Cockpit Voice Recorder

The CVR (Image 2) was found in external good condition.

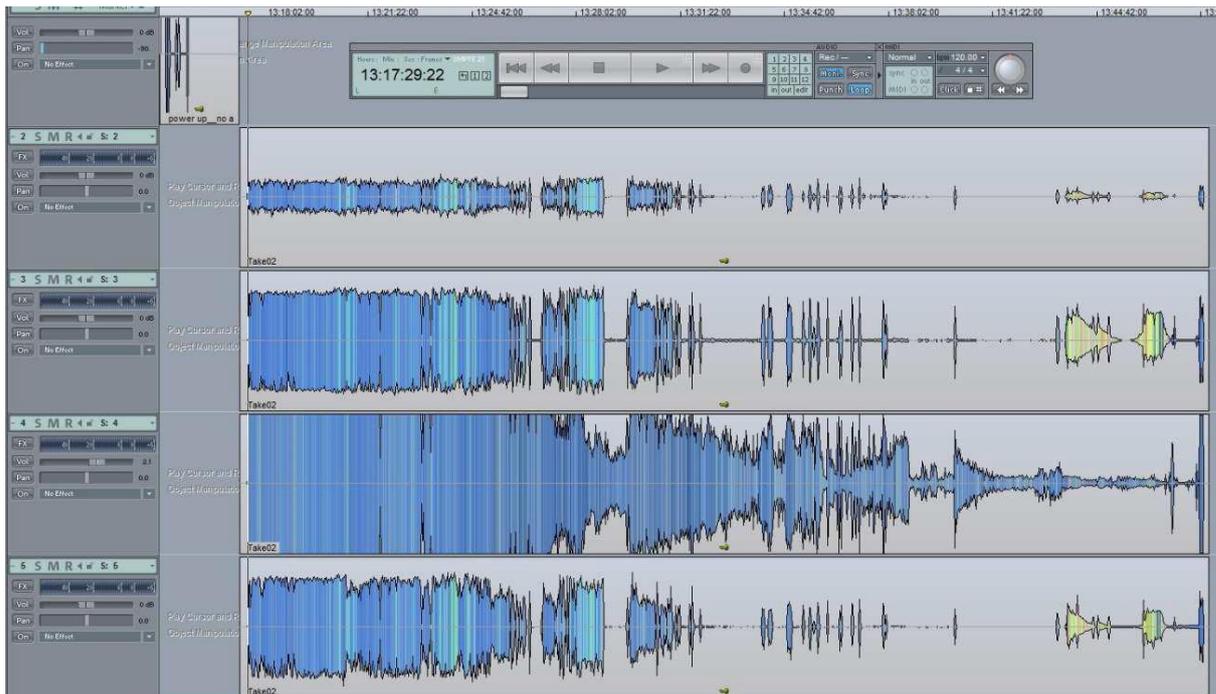
Image 4: Identification of tracks is based on the CVR's CMM

The 4 audio signals were found to be in bad quality. No audio data consistent with a flight phase (take-off, cruise, landing, ...) was found.

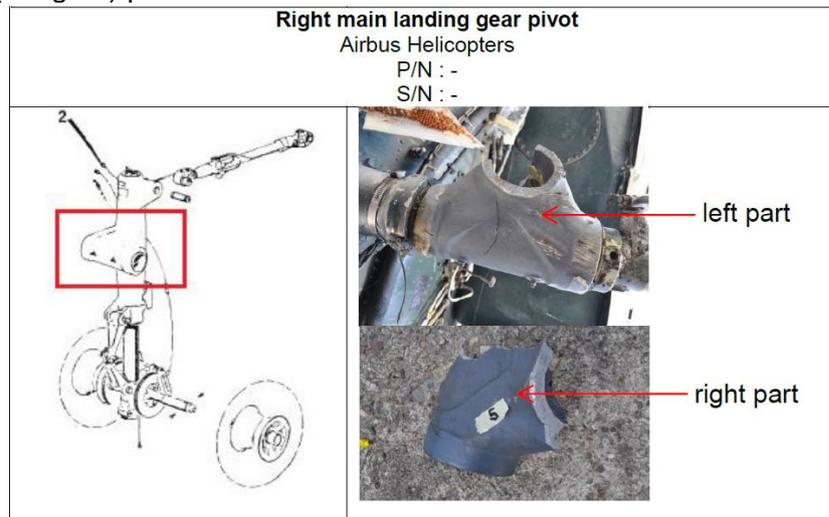
Image 8: Landing gear

The objective of the examination was to determine the nature and the origin of the right main landing gear (Image 8) pivot fracture.

Two pieces from the pivot were transported to BEA France (referenced as the right part and the left part in the following). The examination of the matching fracture surfaces highlighted that at least one other piece was missing.

Binocular examination of the fracture surfaces showed a matt and granular appearance, characteristic of a sudden failure (**Appendix B**). Some local areas showed matting damage. It was not possible to determine the crack propagation direction, as only a few chevron markings were observed.

The fracture of the right main landing gear pivot was sudden, as a result of overload. There was no observation of any previous damage such as fatigue, corrosion or casting defect.
