Report on Accident that Occurred at Airport of Pristina "Adem Jashari" on 12 May 2015, involving a Helicopter Aerospatiale Puma SA330 J with registration EI-SAI, operated by Starlight Aviation

Investigation Report No:	ZKM KHAIA 004/ R
Type of Occurrence:	Accident
Date:	12 May 2015
Location:	Pristina International Airport Adem Jashari
Aircraft:	Rotary Wing Puma SA330 J Helicopter
Manufacturer / Model:	Airbus Helicopters / Serial no:1545
Registration:	EI-SAI
Injuries to Persons:	2 Minor injuries to rear crew
Damage:	Damaged beyond economic repair
Other Damage:	Impact damage to runway surface

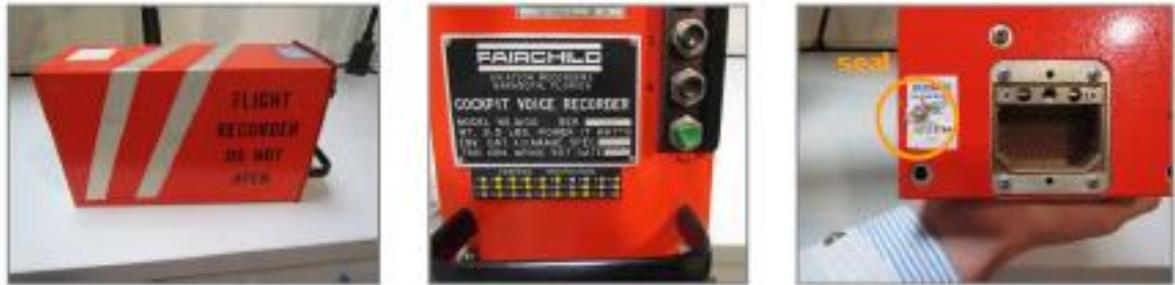
Image 2: Cockpit Voice Recorder

The recorder had no visible damage. CVR download took place at the BEA in France on 26 May 2015.

The CVR (Image 2) was found in external good condition.

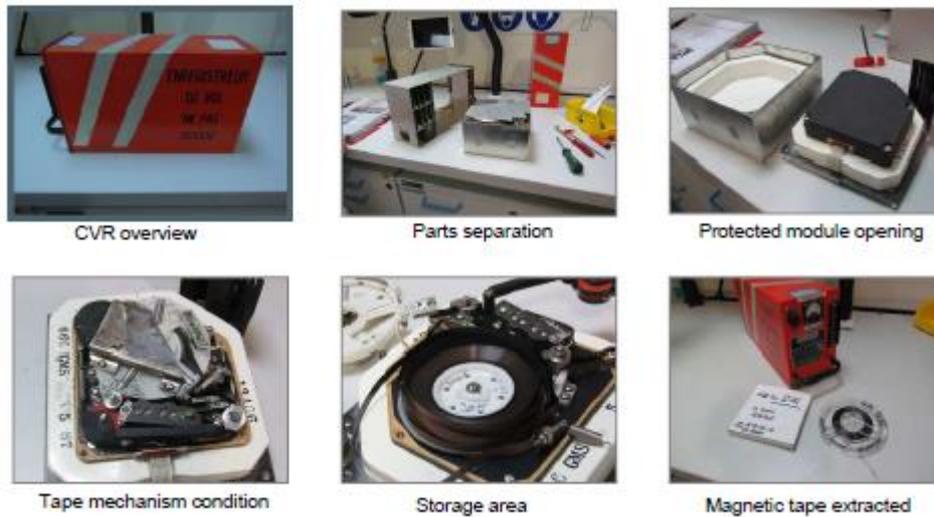
Image 3: Opening of Cockpit Voice Recorder

The direct readout of the CVR unit of the event (S/N 52061) failed. No audio signal was delivered. The IIC, following BEA investigators proposal and with the operator agreement, agreed to open the unit in order to perform the magnetic tape extraction.

The tape was successfully extracted from the protected module. However, the tape was found severally folded at the location of the motor drive capstan and in a mess in the storage area.

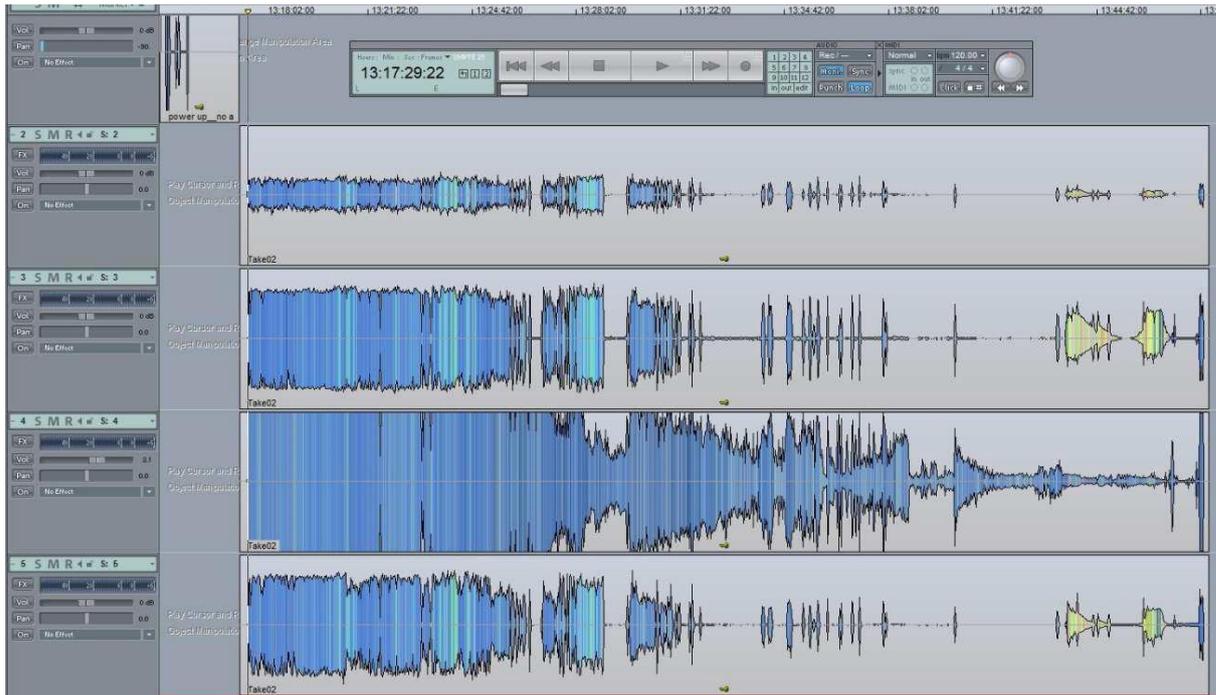
Image 4: Identification of tracks is based on the CVR's CMM

The 4 audio signals were found to be in bad quality. No audio data consistent with a flight phase (take-off, cruise, landing, ...) was found.

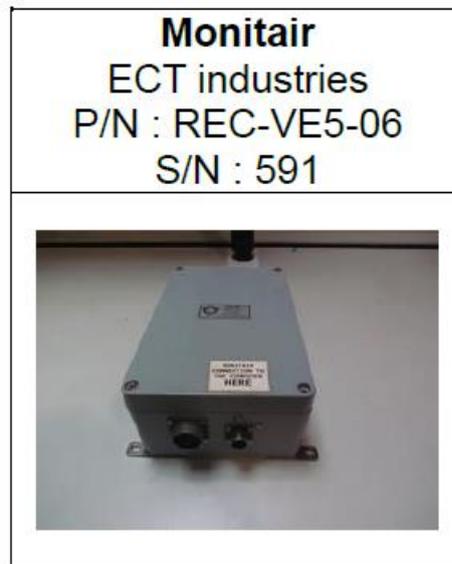
Image 5: Monitair

The Monitair was found in good condition. The computer was opened and the battery that allows the data retention was measured at 7,5 V. According to the manufacturer, even if the value was sufficient to maintain the data, the battery should be recharged. The Monitair was then connected to an external power supply. An internal relay was found to be continuously shuttling. The manufacturer indicated the recharge should be stopped, and the data download in its facilities.

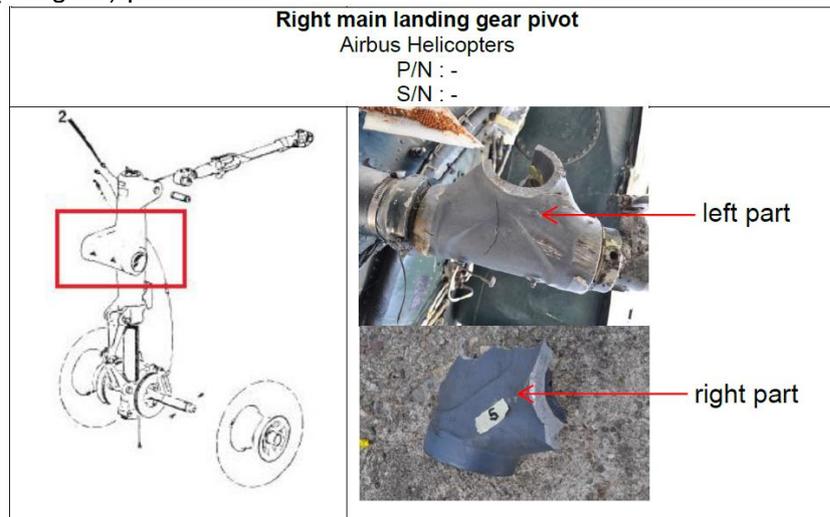
Image 8: Landing gear

The objective of the examination was to determine the nature and the origin of the right main landing gear (Image 8) pivot fracture.

The fracture of the right main landing gear pivot was sudden, as a result of overload. There was no observation of any previous damage such as fatigue, corrosion or casting defect.

- The right main landing gear leg failed under over-load.
- The helicopter continued the left rotation about the yaw axis, and the right rotation about the roll axis increased.

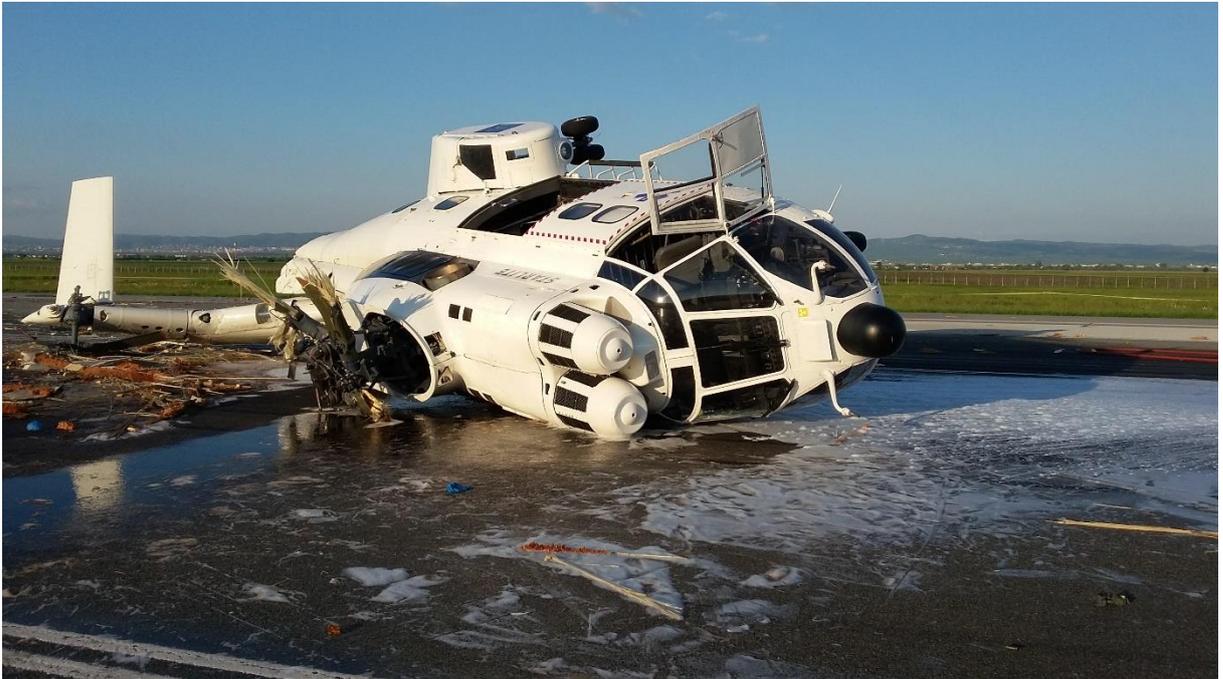
Image 9: Overview of the helicopter on runway

The helicopter made a firm touchdown at the beginning of the runway, followed by a bounce. When it touched down again it veered left and tipped over on its right side during which the right main landing gear collapsed. The helicopter sustained substantial damage.

The wreckage of the helicopter was found at the beginning of RWY 35 (Image 9). Image 10 identifies the accident site location and Image 11 the final resting position of the helicopter.

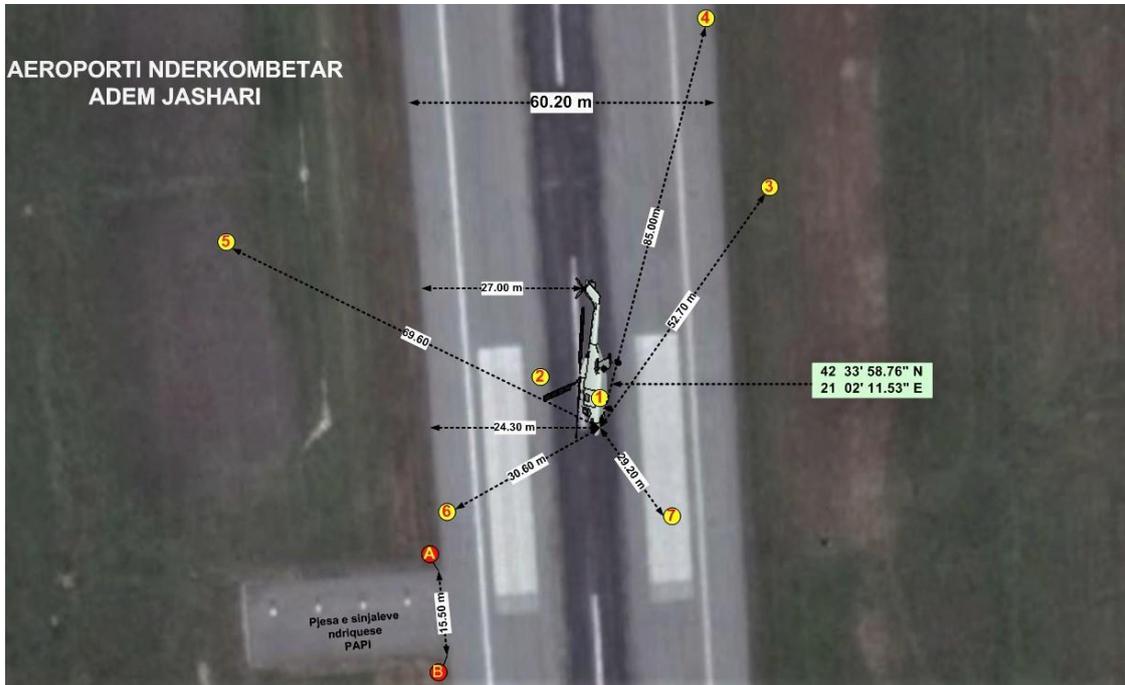
Image 11: Sketch of the final helicopter position

The brief for the simulated engine failure after LDP was for the helicopter to touch down at the mid-runway point. However, the final resting position of the helicopter was within the first quarter of the runway. The PIC identified that in the latter stages of the approach, the rate of descent was higher than normal, and thus he had to apply full collective to cushion the landing. In addition, the PIC confirmed that the helicopter ,flared a little too much...the helicopter came to an almost stop. It is therefore considered likely that the initial flare prior to touch down was higher than the maximum 10° required for the run-on landing. An increased flare will reduce ground speed and lift over the rotors, thereby necessitating increased collective to maintain height. If the available collective lift is insufficient, the rate of descent will increase causing a firm hard landing. The combination of a bounced landing, the application of full collective with decaying NR to cushion the landing, a high centre of gravity and a narrow tricycle undercarriage, all contributed to the risk of dynamic rollover as was the case in this particular accident.

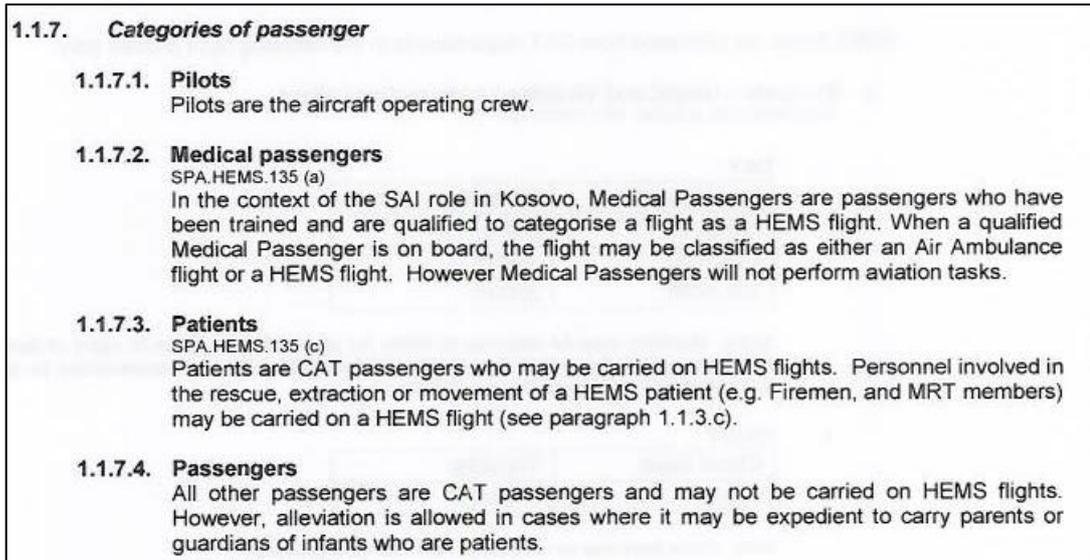
Image 16: Categories of passenger

It shows that when a qualified medical passenger is on board, the flight may be classified as either an Air Ambulance flight or a HEMS flight.

The Investigation notes that medical crew passengers were being carried during a flight detail that involved practice engine failures. During such OEI training there are additional risks, and the Investigation is of the opinion that, as such, the carriage of passengers is not appropriate. In addition, following the accident, the passengers did not immediately evacuate the helicopter. The passengers had previously been carried on the helicopter used by the Operator, and would have been briefed on what to do following an emergency. It was not determined why the passengers did not immediately exit the aircraft, but it is possible they were experiencing shock following the event.

That Starlite Aviation should ensure that passengers are not carried on flights involving simulated engine failures, or other flight training exercises that expose the helicopter to additional risk.

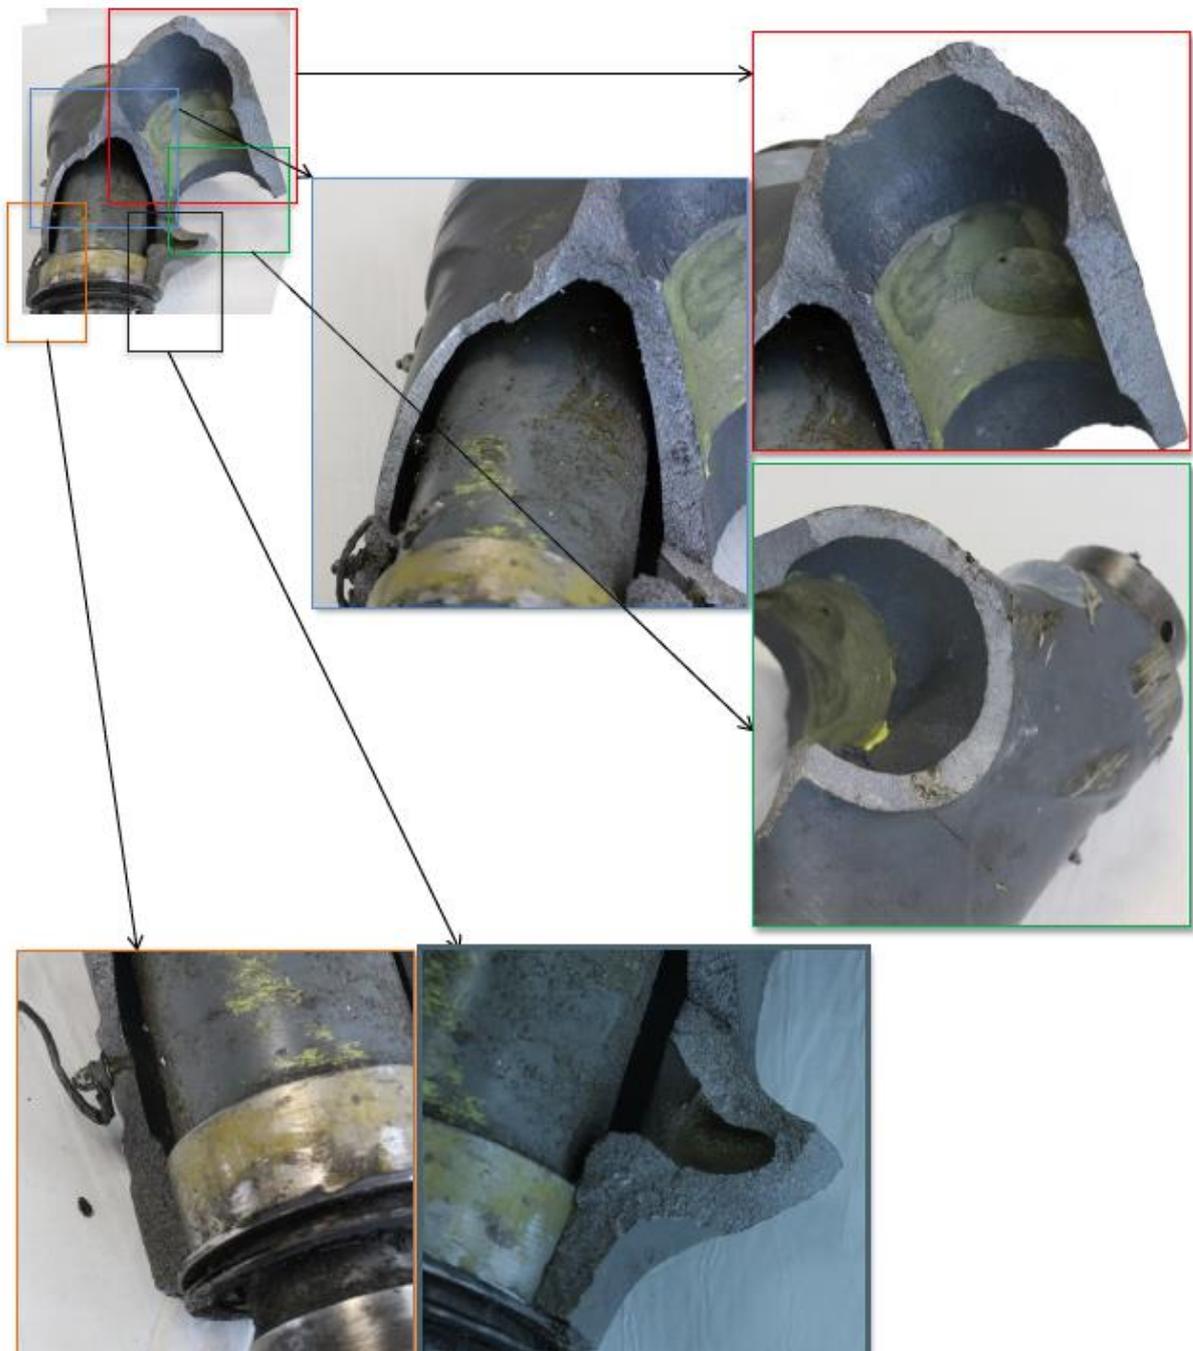
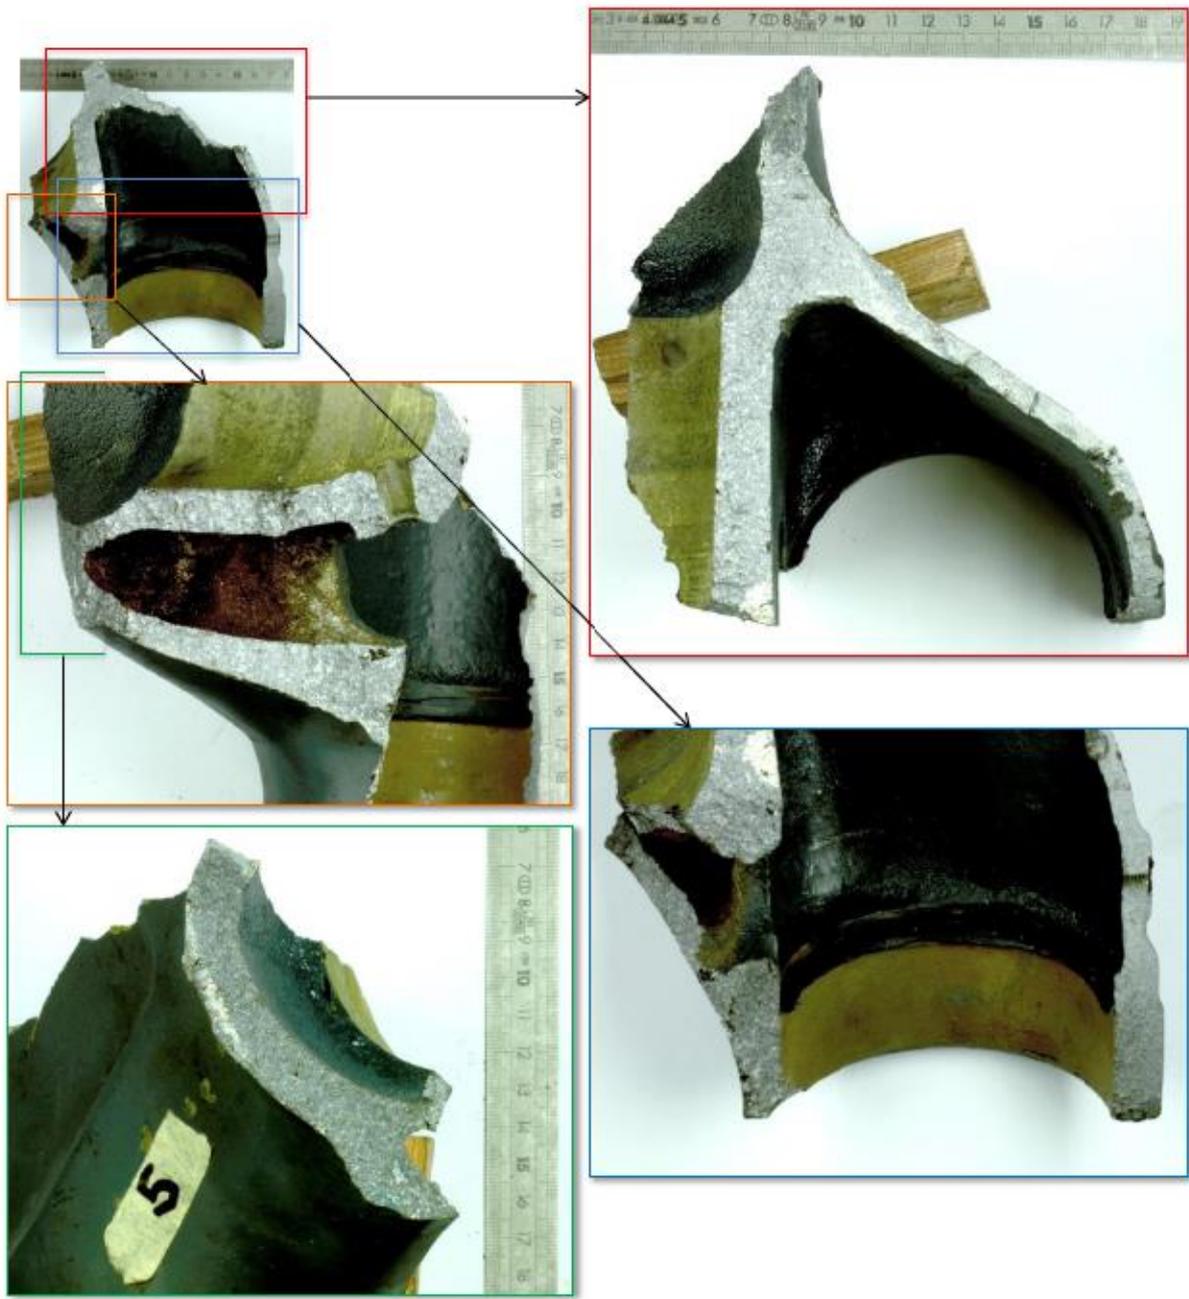
Fractographic examination of the left part of the right main landing gear pivot
(Source: BEA/FRANCE)

Binocular examination of the fracture surfaces showed a matt and granular appearance, characteristic of a sudden failure (**Appendix B**). Some local areas showed matting damage. It was not possible to determine the crack propagation direction, as only a few chevron markings were observed.
