Komisioni për Hetimin e Aksidenteve dhe Incidenteve Aeronautike
/Vazduhoplovna Komisija za Istraživanje Nesreća i
Incidenata/Aeronautical Accidents and Incidents Investigation
Commission

Report on Serious Incident of aircraft AIRBUS A320-232, SX-ORG at
the International Airport of Pristina "Adem Jashari", on 1 December
2017

**Raport mbi incidentin e rëndë të avionit Airbus A320-232, Orange2Fly, SX-ORG
në Aeroportin Ndërkombëtar të Prishtinës, më 1 dhjetor 2017**

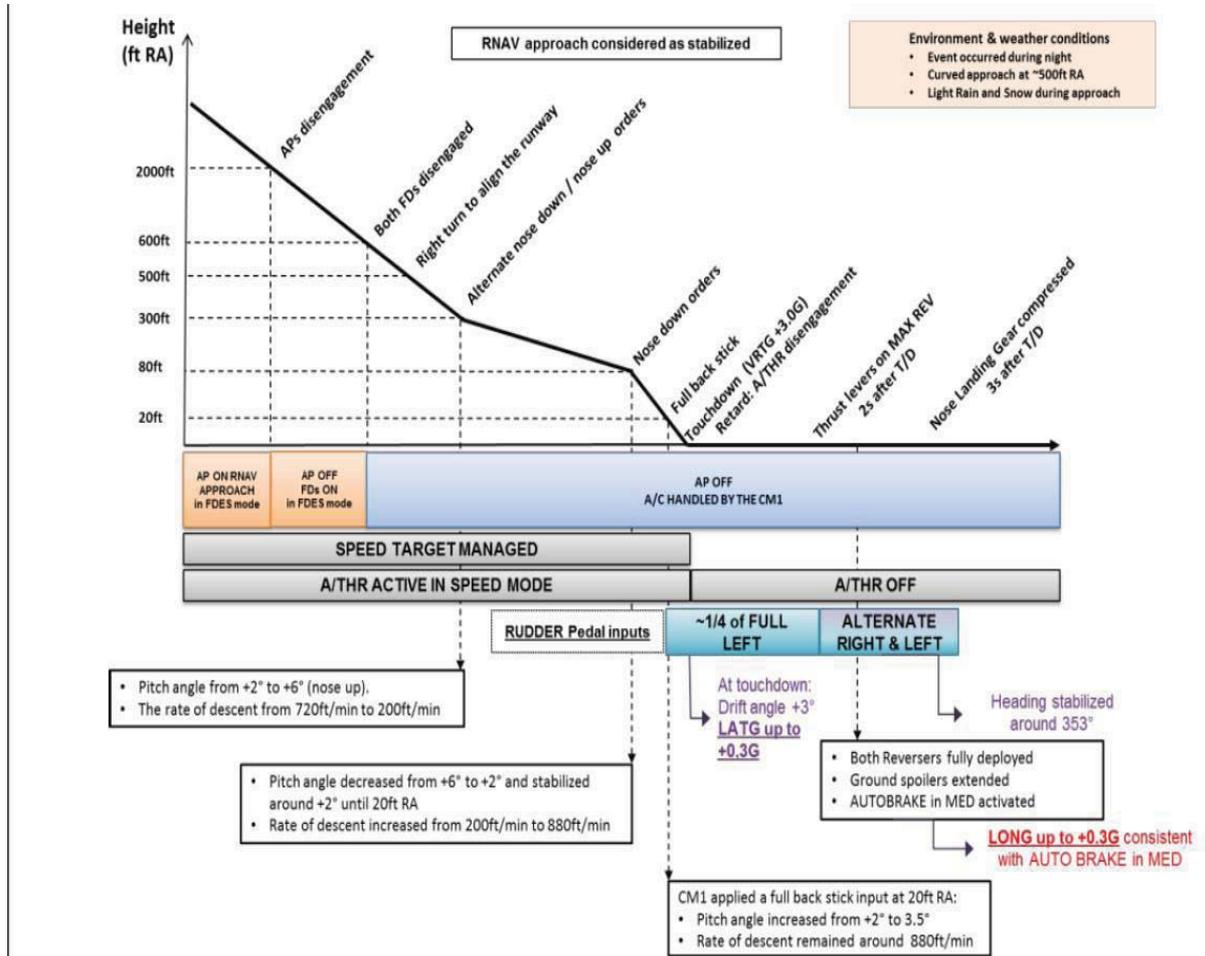
Figure 8: The approach sequence and touch down

The above mentioned are graphically illustrated in the figure below.

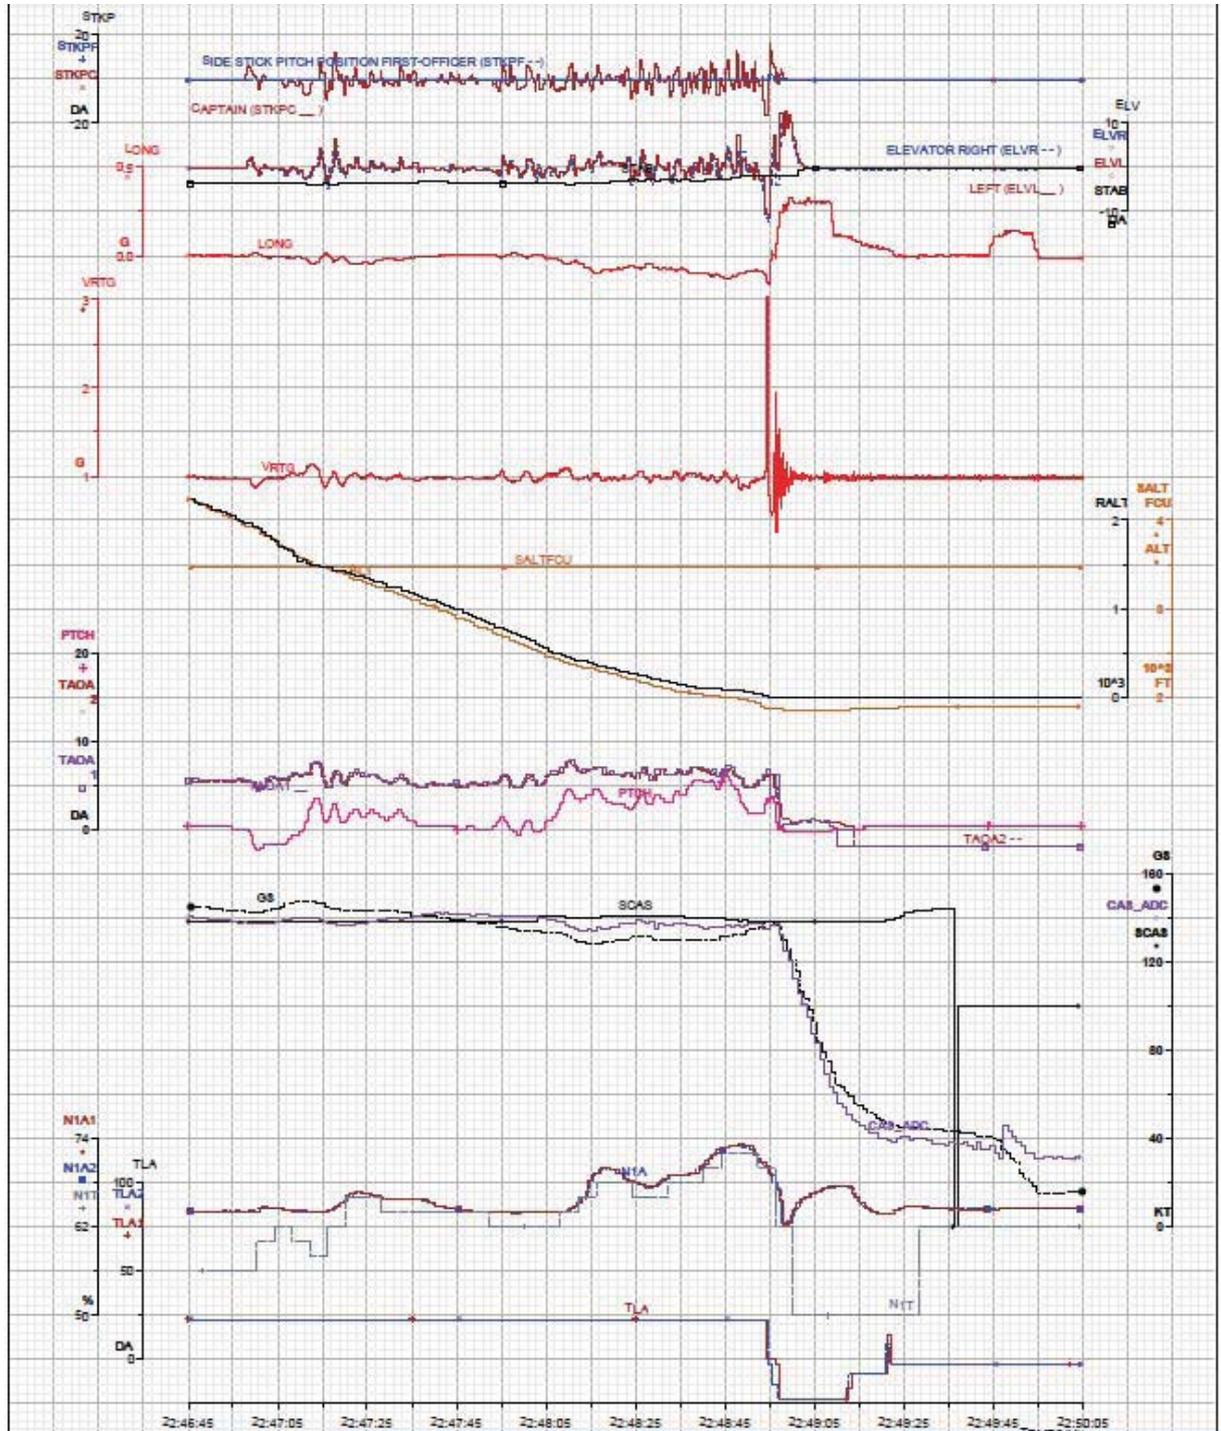
Figure 9: FDR parameters of the approach phase

The figure shows the approach phase on the longitudinal axis.

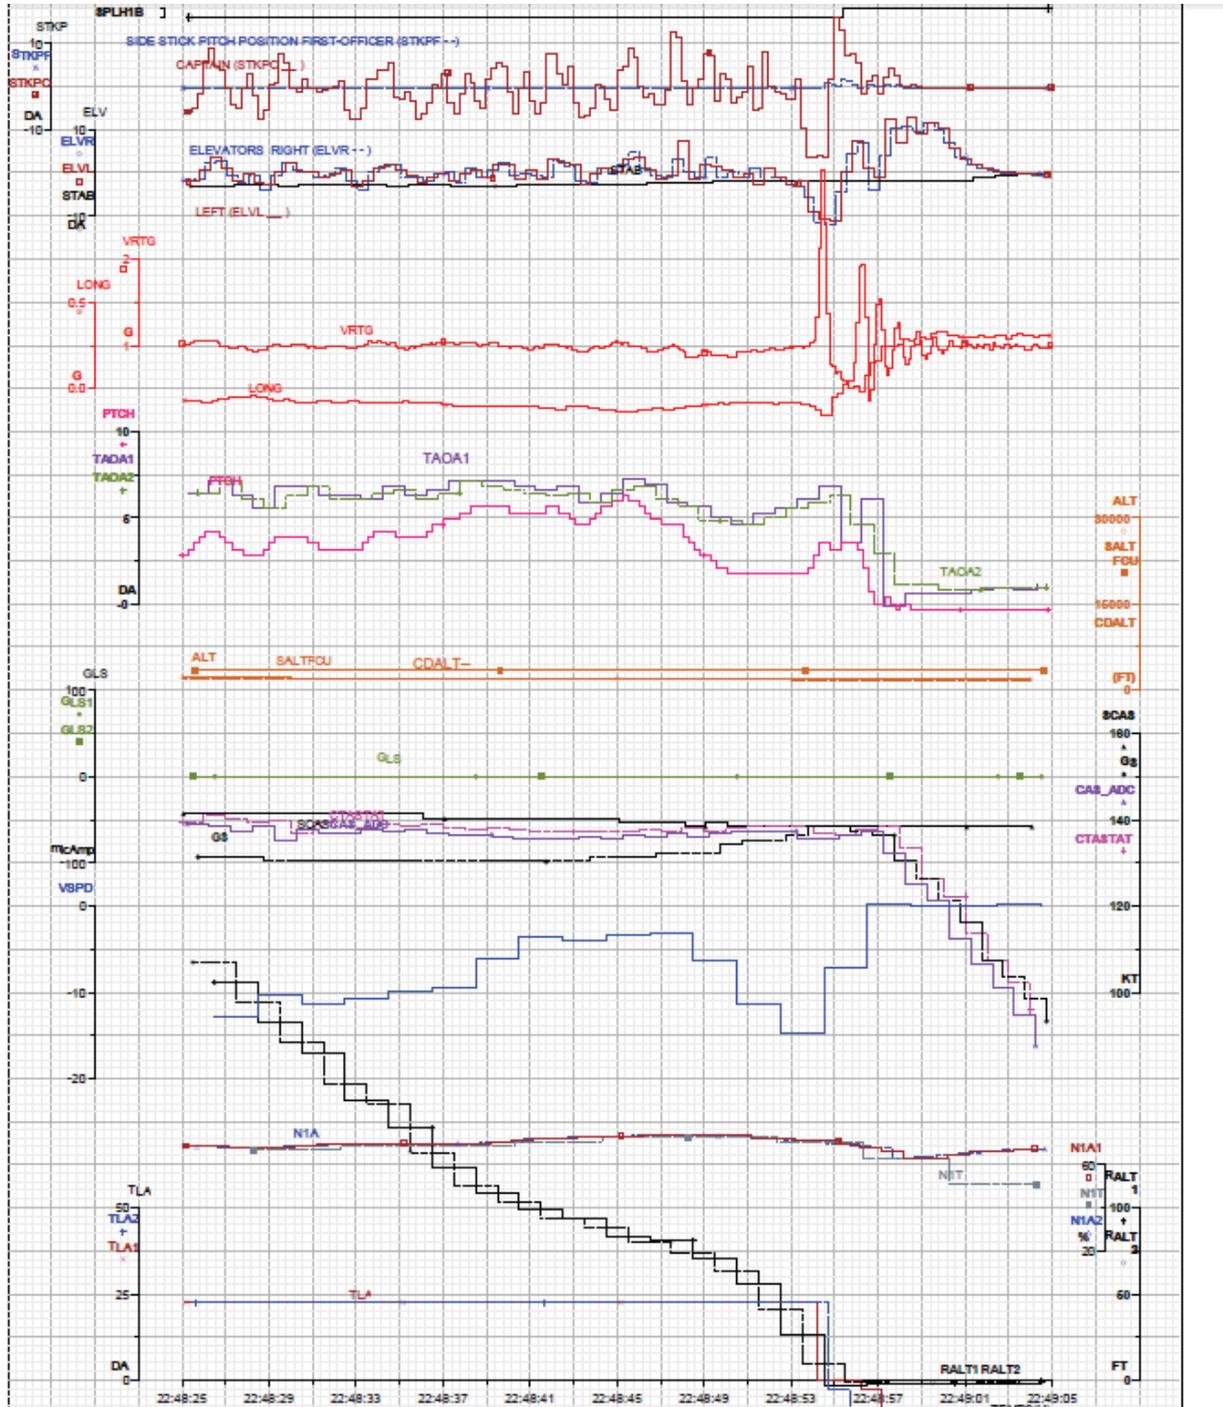
Figure 10: FDR parameters of the landing phase

The figure shows the landing phase on longitudinal axis.

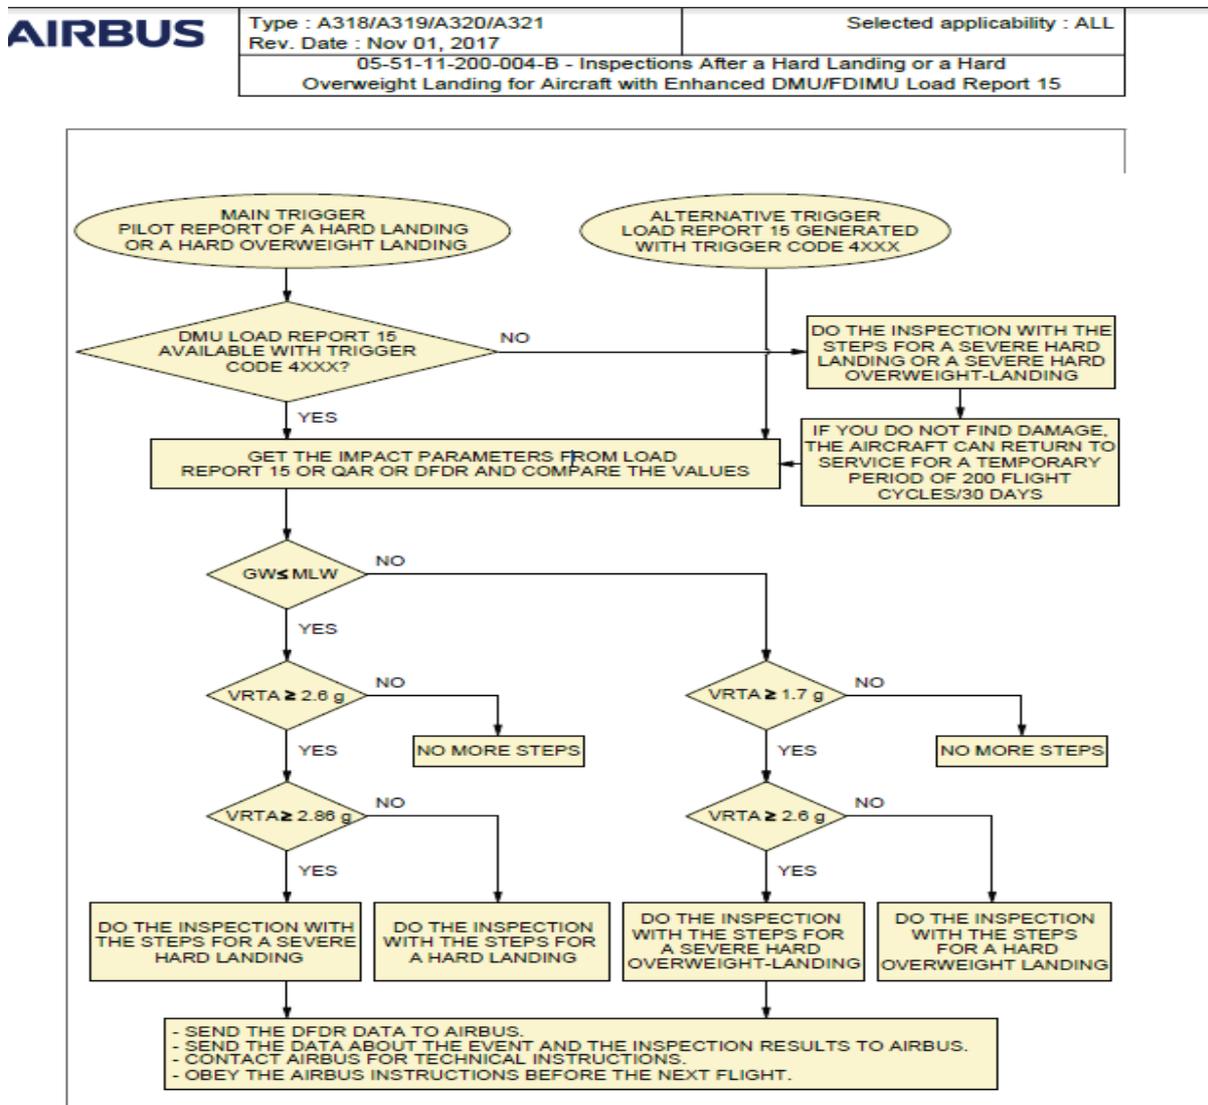
Figure 22: Hard Landing Inspections Chart

The specific inspections with the steps for a severe hard landing need to be carried out to the aircraft by the engineers after the exceedance of parameters.

1. NLG can be returned to service with no further action required.
2. LH MLG can be returned to service, provided that AMM 05-51-11 "Severe Hard Landing" inspections has been completed with NIL findings
3. RH MLG can be returned to service provided that :
 - 3.1. RH MLG shock absorber assembly (excluding RH MLG sliding tube) including all internal shock absorber components are considered to be un-serviceable and must be replaced prior to next flight. RH MLG unserviceable components must be scrapped by component mutilation.
 - 3.2. AMM 05-51-11 "Severe Hard Landing" inspections has been completed with NIL findings.
