Report on Accident that Occurred at Airport of Pristina "Adem Jashari" on 12 May 2015, involving a Helicopter Aerospatiale Puma SA330 J with registration EI-SAI, operated by Starlight Aviation

Investigation Report No:	ZKM KHAIA 004/ R
Type of Occurrence:	Accident
Date:	12 May 2015
Location:	Pristina International Airport Adem Jashari
Aircraft:	Rotary Wing Puma SA330 J Helicopter
Manufacturer / Model:	Airbus Helicopters / Serial no:1545
Registration:	EI-SAI
Injuries to Persons:	2 Minor injuries to rear crew
Damage:	Damaged beyond economic repair
Other Damage:	Impact damage to runway surface

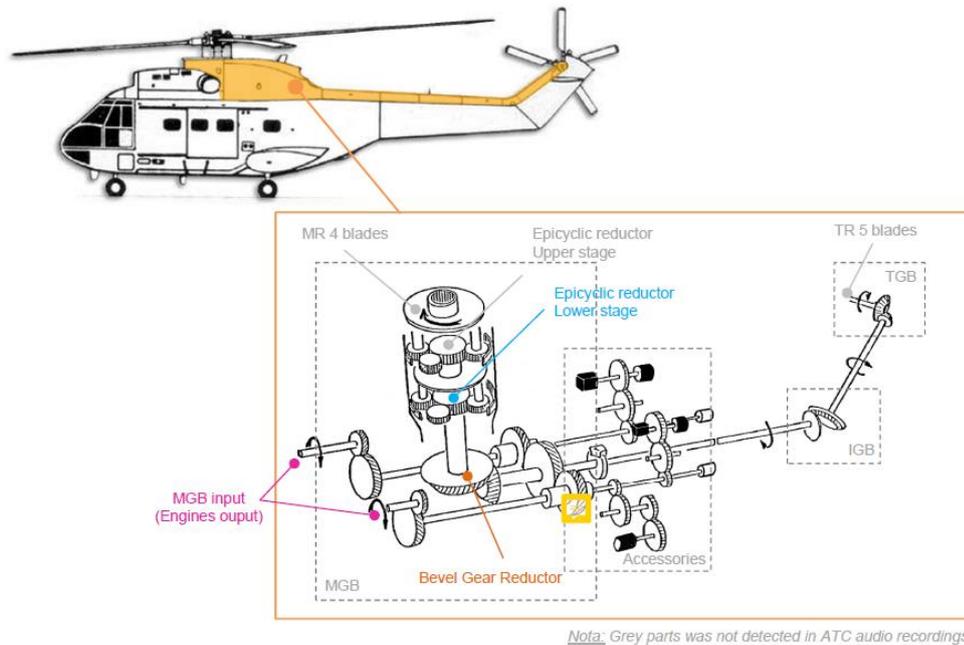
Image 6: MGB

Some frequencies appeared in the spectra and were mainly coming from the following transmission parts (Image 6):

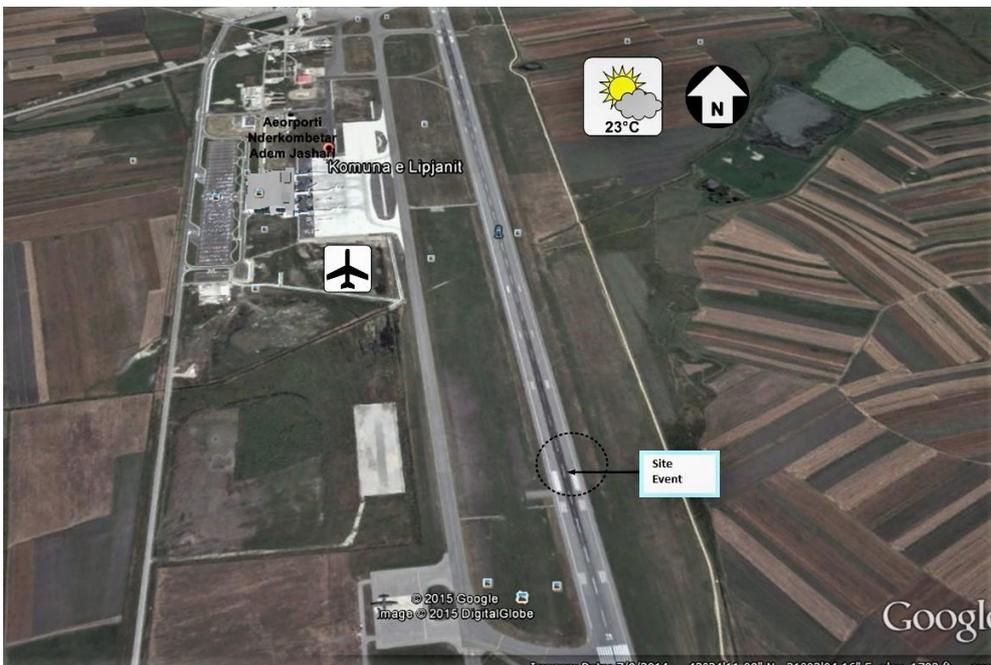
Image 10: event site

The wreckage of the helicopter was found at the beginning of RWY 35 (Image 9). Image 10 identifies the accident site location and Image 11 the final resting position of the helicopter.
