Komisioni për Hetimin e Aksidenteve dhe Incidenteve Aeronautike
/Vazduhoplovna Komisija za Istraživanje Nesreća i
Incidenata/Aeronautical Accidents and Incidents Investigation
Commission

Report on Serious Incident of aircraft AIRBUS A320-232, SX-ORG at
the International Airport of Pristina "Adem Jashari", on 1 December
2017

**Raport mbi incidentin e rëndë të avionit Airbus A320-232, Orange2Fly, SX-ORG
në Aeroportin Ndërkombëtar të Prishtinës, më 1 dhjetor 2017**

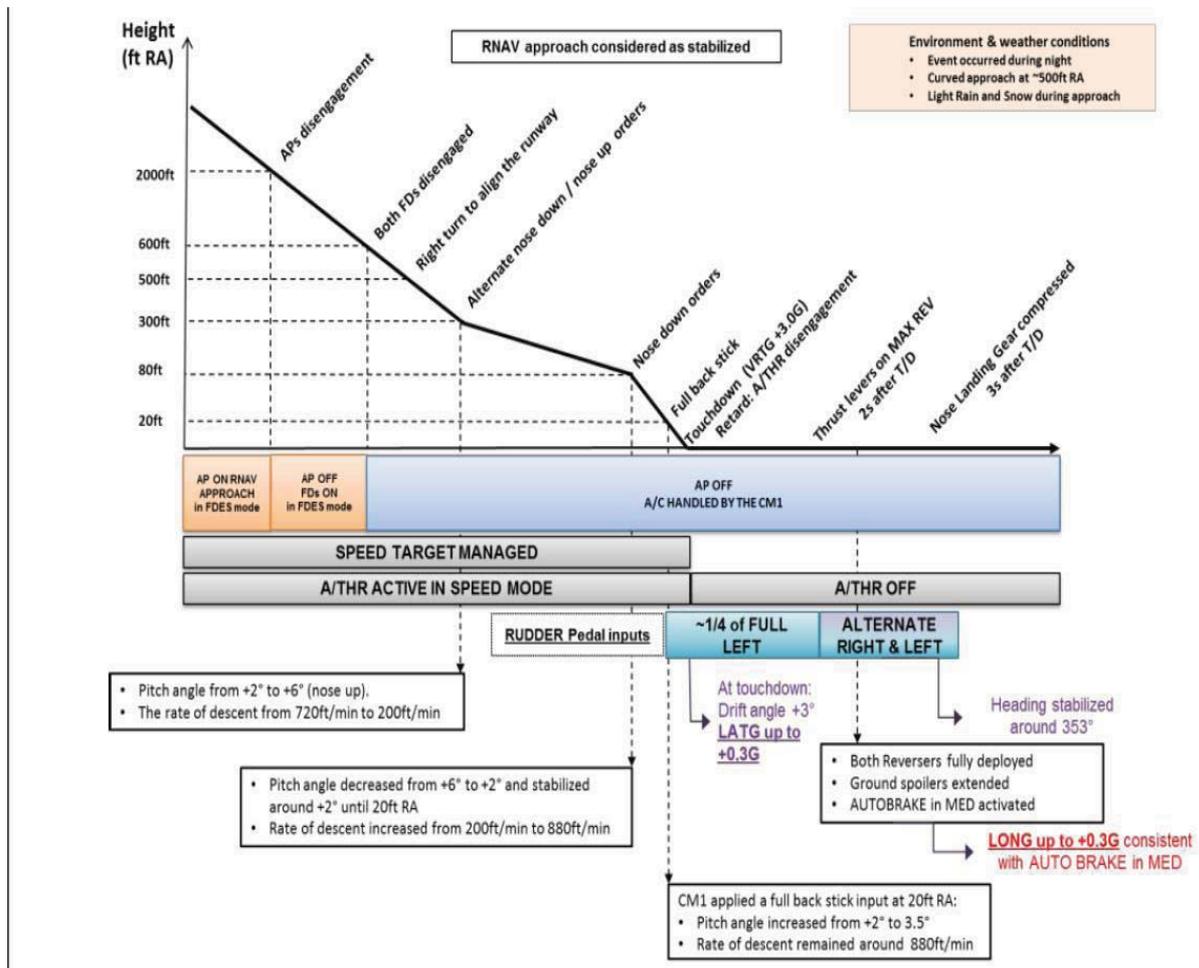
Figura 8: Sekuenca e arritjes dhe prekja në tokë

- +3.5° të këndit të pjerrësisë.
 - -17ft/s (±60cm/s) të shpejtësisë së rillogaritur vertikale të avionit.
 - +3.0G të faktorit të ngarkesës vertikale.
 - +2.5° e këndit rrotullues (krahu i djathtë poshtë).
 - +3° e këndit të rrëshqitjes (hunda e avionit në të majtë të pistës)
 - Levat e shtytësit ishin shtyrë në "IDLE" dhe A/THR u çaktivizua.
 - Ndërprerësit e komponentit të ngritjes filluan të zgjateshin.
 - CAS ishte 135kt (=VLS+2kt).
 - Shpejtësia tokësore ishte 138kt.
- Dhe në boshtin lateral:
- 350° të drejtimit (QFU 353°).
 - +3° të këndit të rrëshqitjes (hunda e avionit drejt pjesës së majtë të pistës).
 - Faktori i ngarkesës laterale ishte në +0.3G (në përputhje me këndin e rrëshqitjes).

Të lartpërmendurat janë ilustruar grafikisht në figurën më poshtë.

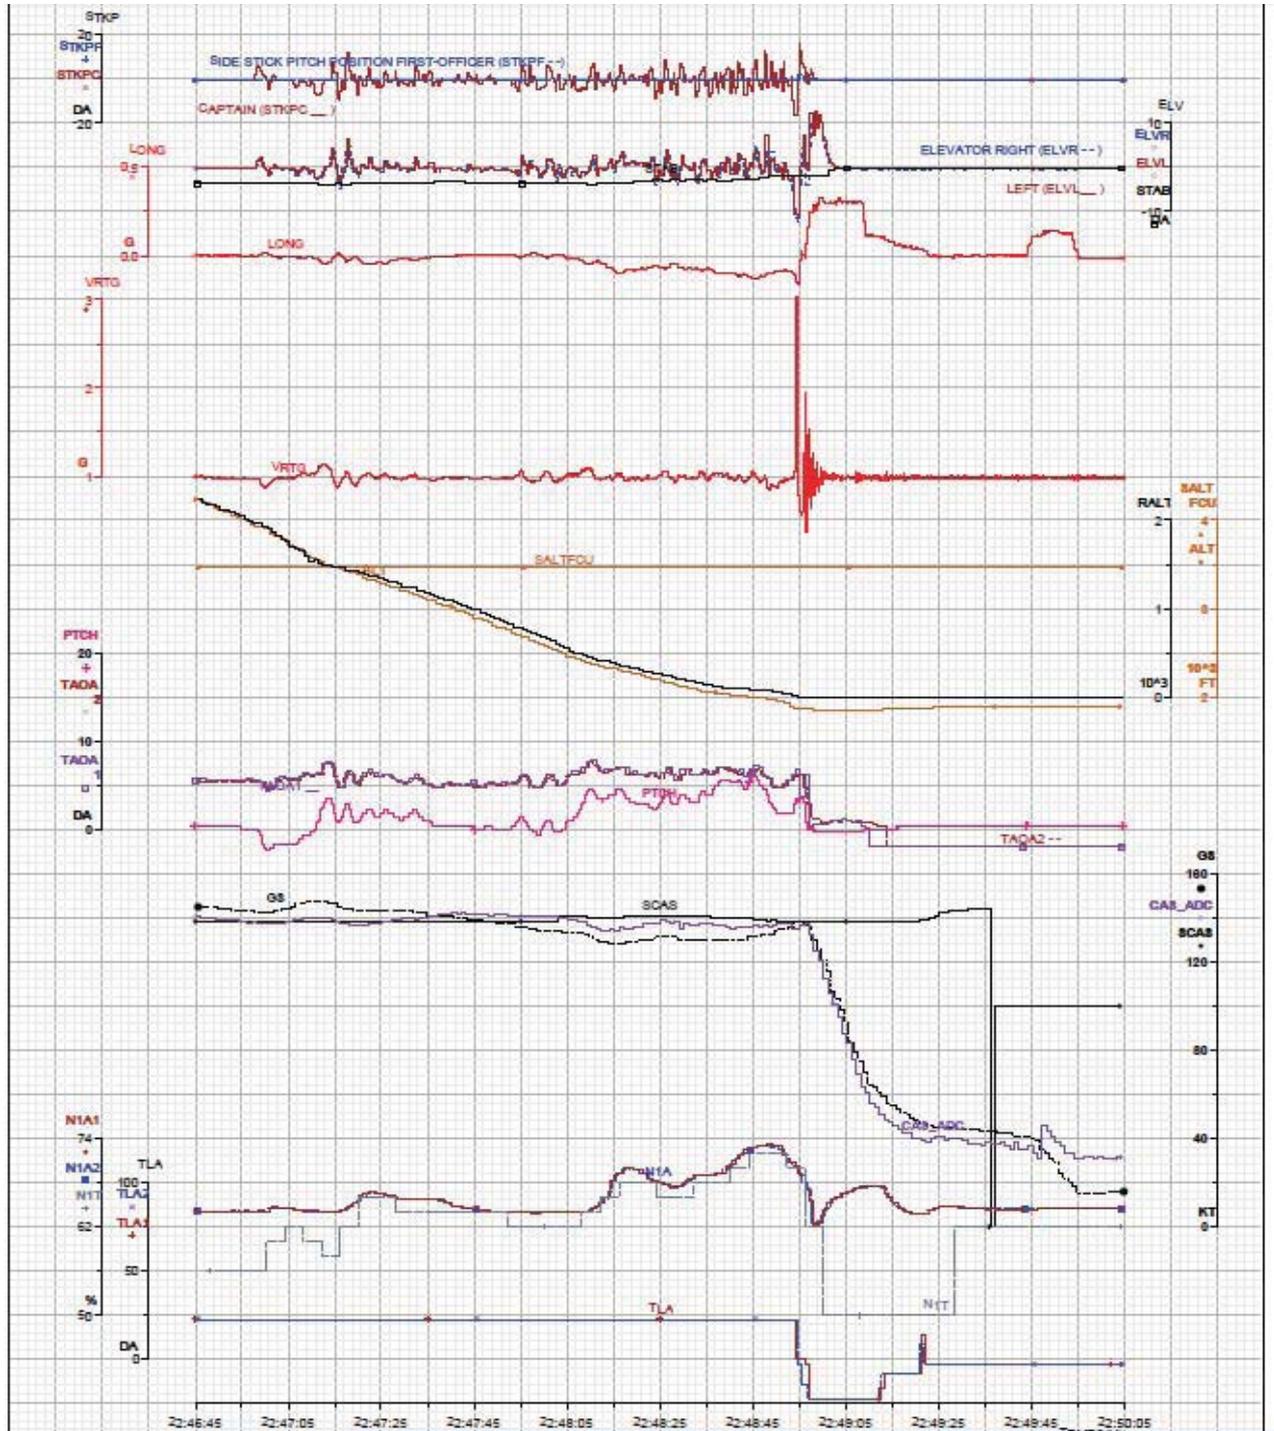
Figura 9: Parametrat e FDR-së të fazës së afrimit

Figura paraqet fazën e afrimit në boshtin gjatësor.

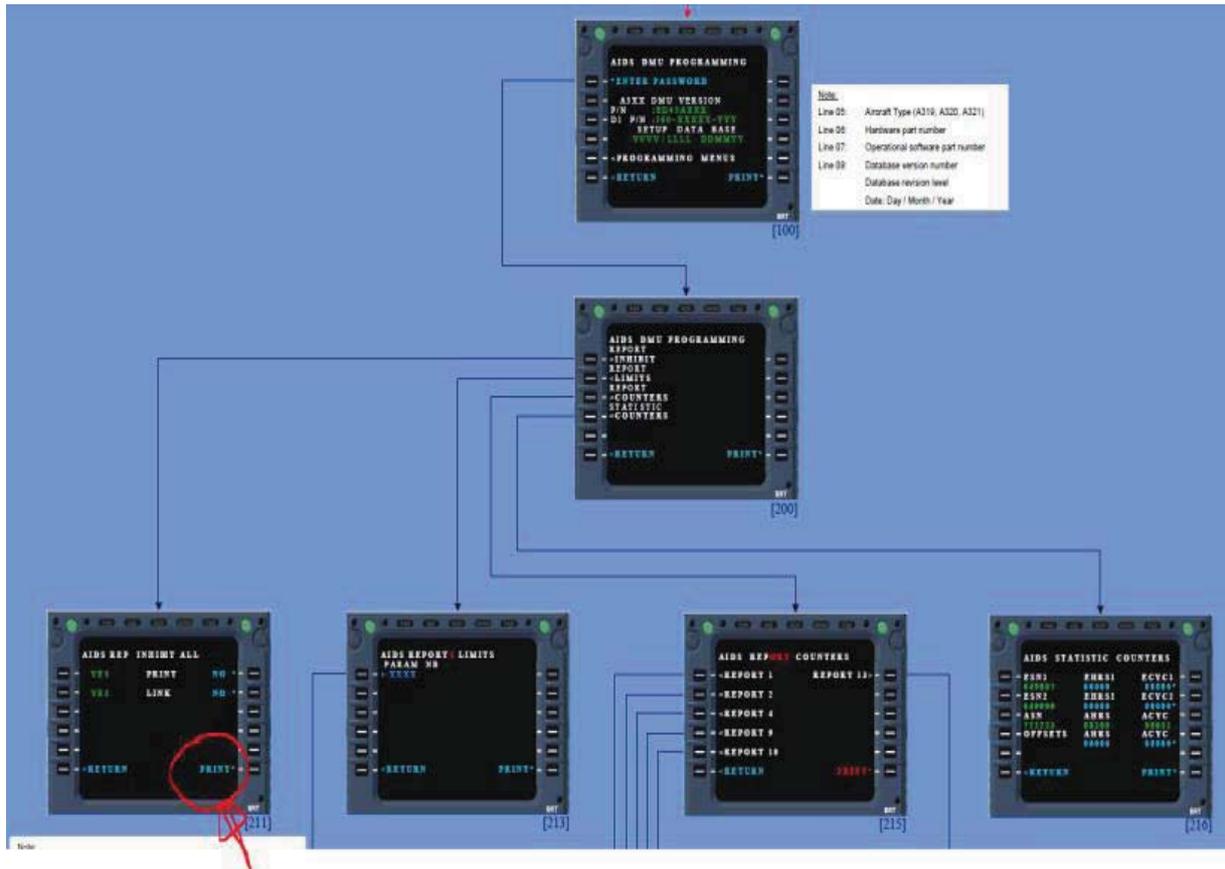
Figura 18: Procedurat e printimit në DMU

Printimi automatik mund të programohet nga Operatorët, në rastin e incidentit janë caktuar parametrat e mëposhtëm avion se si të bëhet printimi i programimit AIDS DMU.

Nga detyra AMM 31-36-00-740-016 A Procedurat e Programimit të Ndërfaqes dhe Njesisë për Menaxhimin e të Dhënave të Fluturimit (FDIMU). Nën-detyra 31-36-00-740-076-A B. Pengimi i Raportimit të Programueshëm. Klikoni butonin PRINT* (në MCDU LS tasti 6R).

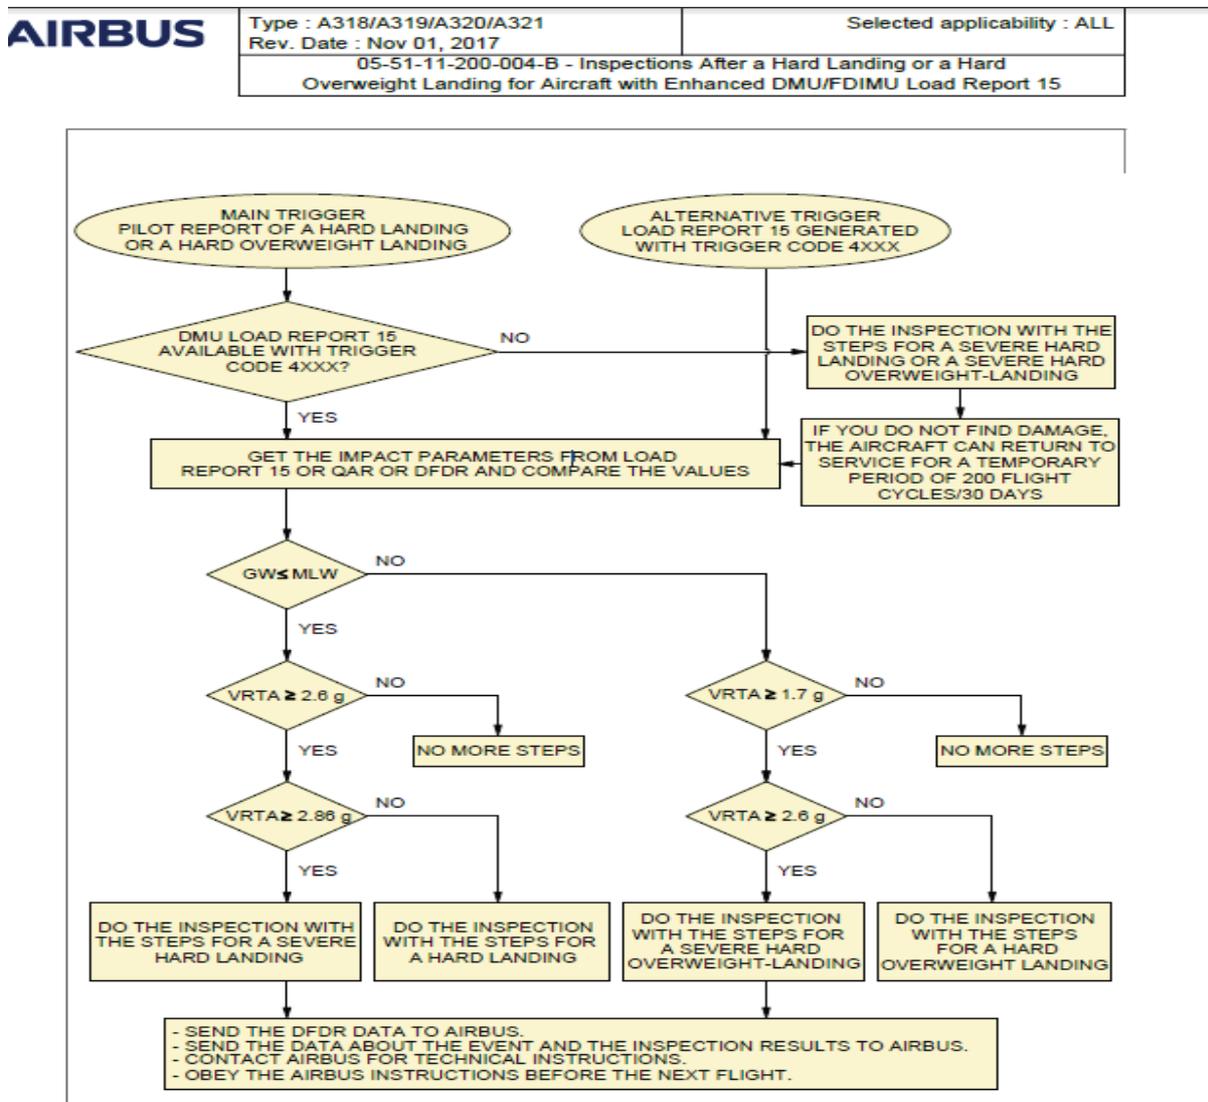
Figura 22: Diagrami i inspektimit të aterimit të vështirë

"pas raportit të ekuipazhit për aterrim të vështirë/me mbipeshë, duhet t'i konfirmoni parametrat e impaktit për ta ditur kategorinë e aterimit. Për ta mësuar këtë, referojuni: - Raportit të ngarkesës së DMU-së 15 ose – leximit të FDRS-së".

Pas tejkalimit të parametrave, Inxhinierët duhet të kryejnë inspektime të veçanta ne avion me hapat për aterrim të vështirë.

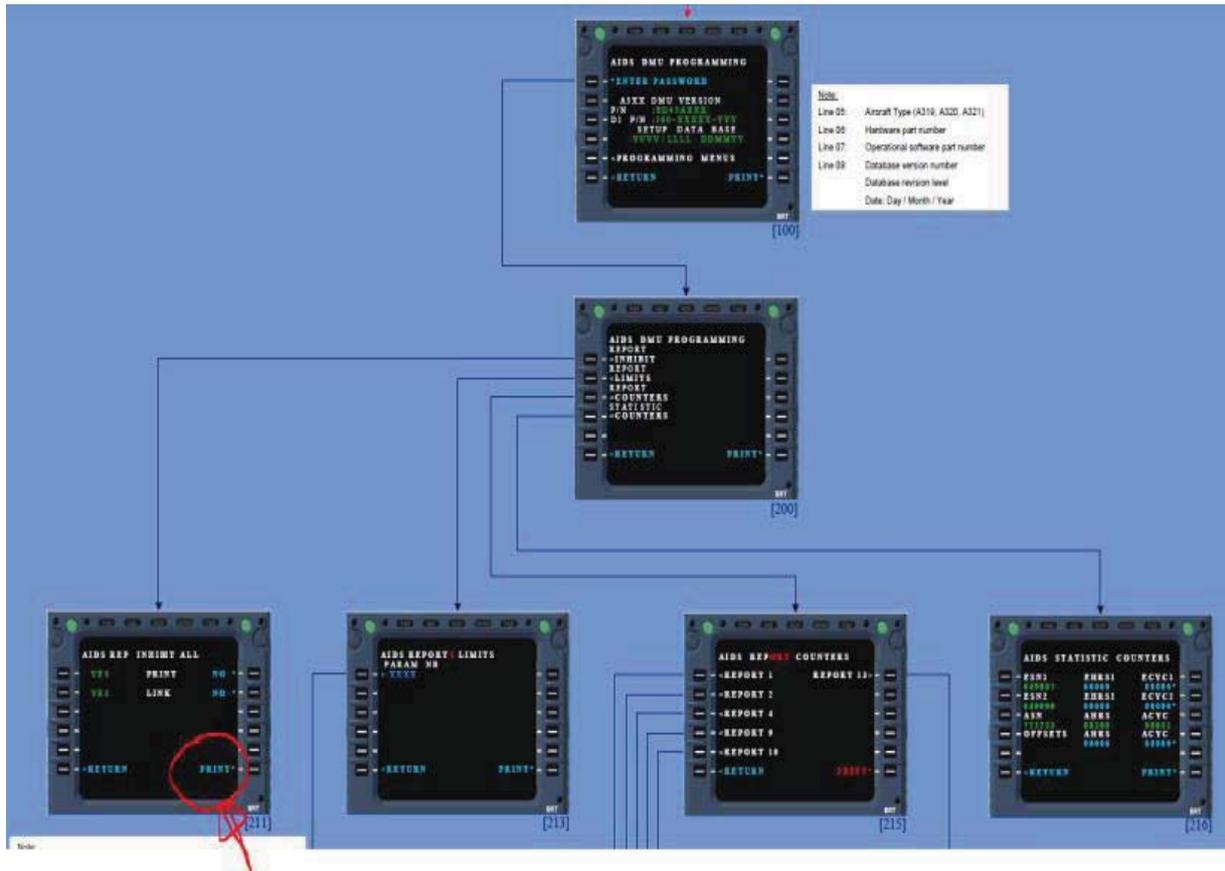
Figure 18: The Printout procedures on DMU

The automatic printout is programmable by the Operators, for the case of the incident the following parameters were set in the aircraft on how to get the AIDS DMU programming print.

From the AMM task 31-36-00-740-016 A Flight Data Interface and Management Unit (FDIMU) Programming Procedures. Subtask 31-36-00-740-076-A B. Programmable Report Inhibit. Click the PRINT* prompt (on MCDU LS Key 6R).

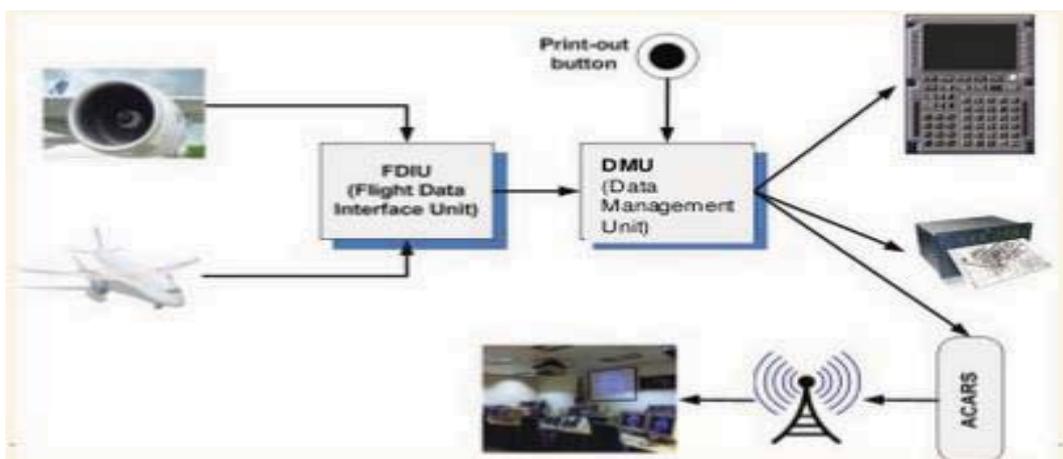
Figure 19: How data is handled and stored in the DMU

The DMU collects the parameters specific to that report. After the data are generated the report may be printed on the flight deck, copied to DAR/SAR or sent directly to the operator through Aircraft Communication Addressing and Reporting System (ACARS) system.

During the Basel – Pristina flight on 1st of December and the 8 consecutive back and forth flights after the incident, there was a missing paper in the DMU therefor no automatic printout of Load Report<15> occurred, and there is no ACARS system integrated to the operator for automatic data transfer to their facilities also according to flight crew there were no any indications shown on ECAM.

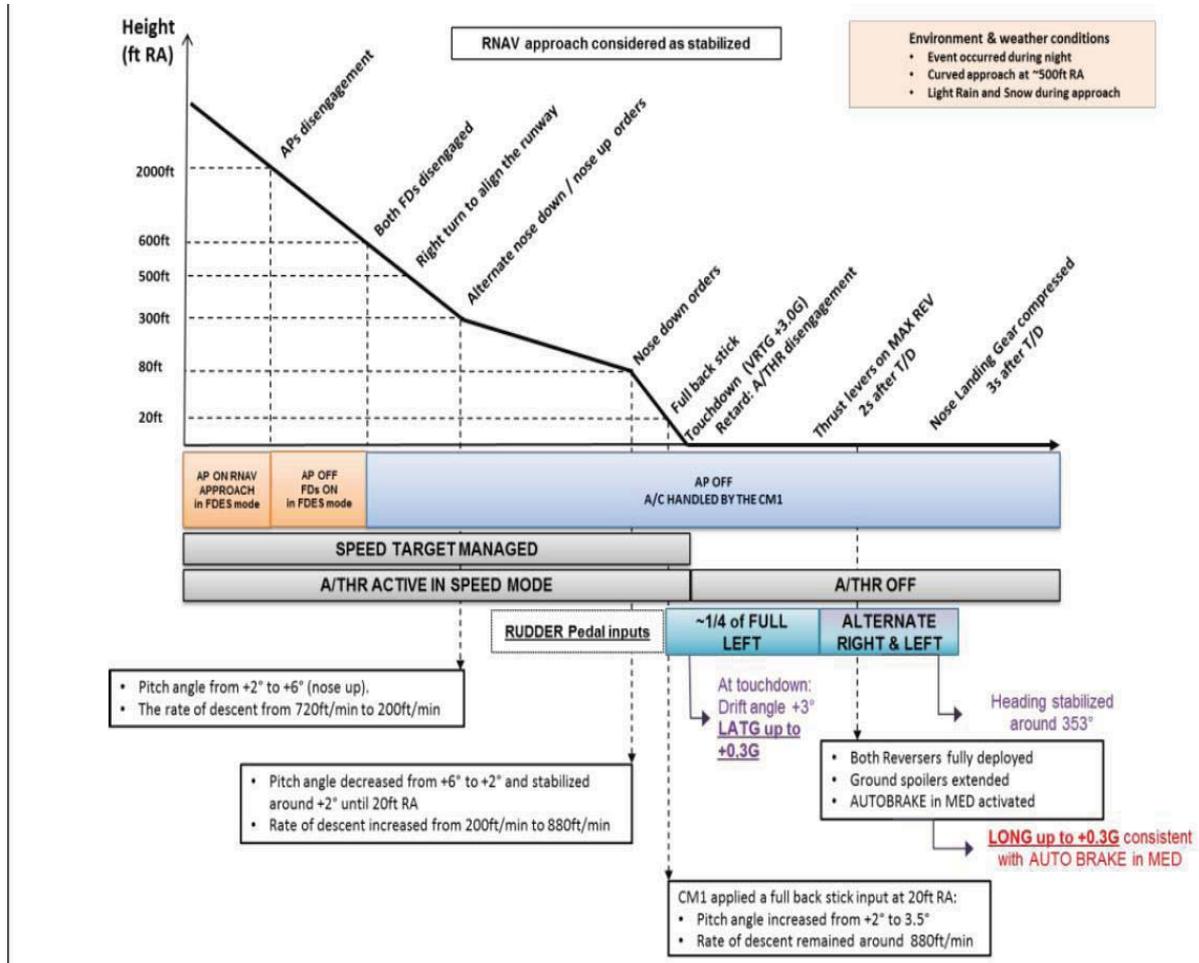
Slika 8: Sekvenca prilaza i dodir

- 350° pravac (QFU 353°).
- +3° ugao zanošenja (kljun vazduhoplova ka levoj strani staze).
- Faktor vertikalnog opterećenja je iznosio +0.3G (u skladu sa uglom zanošenja).

Navedeno je grafički prikazano na slici ispod.

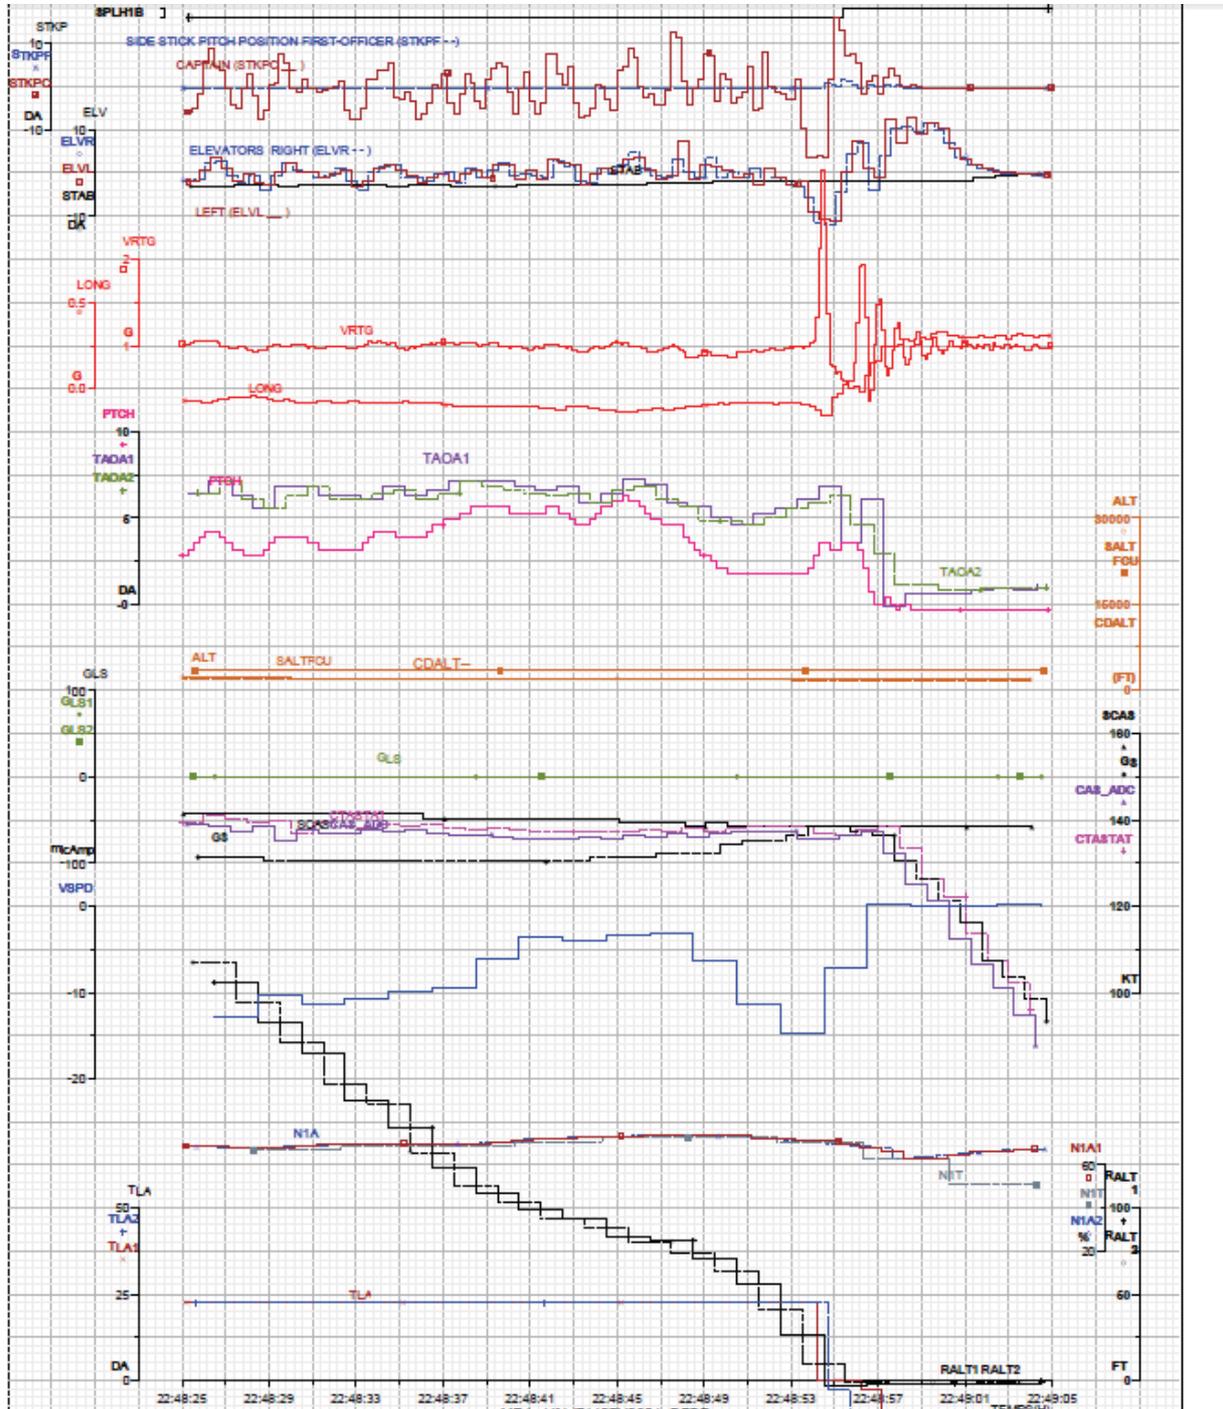
Slika 10: FDR parametri faze sletanja

Slika pokazuje fazu sletanja na uzdužnoj osi.

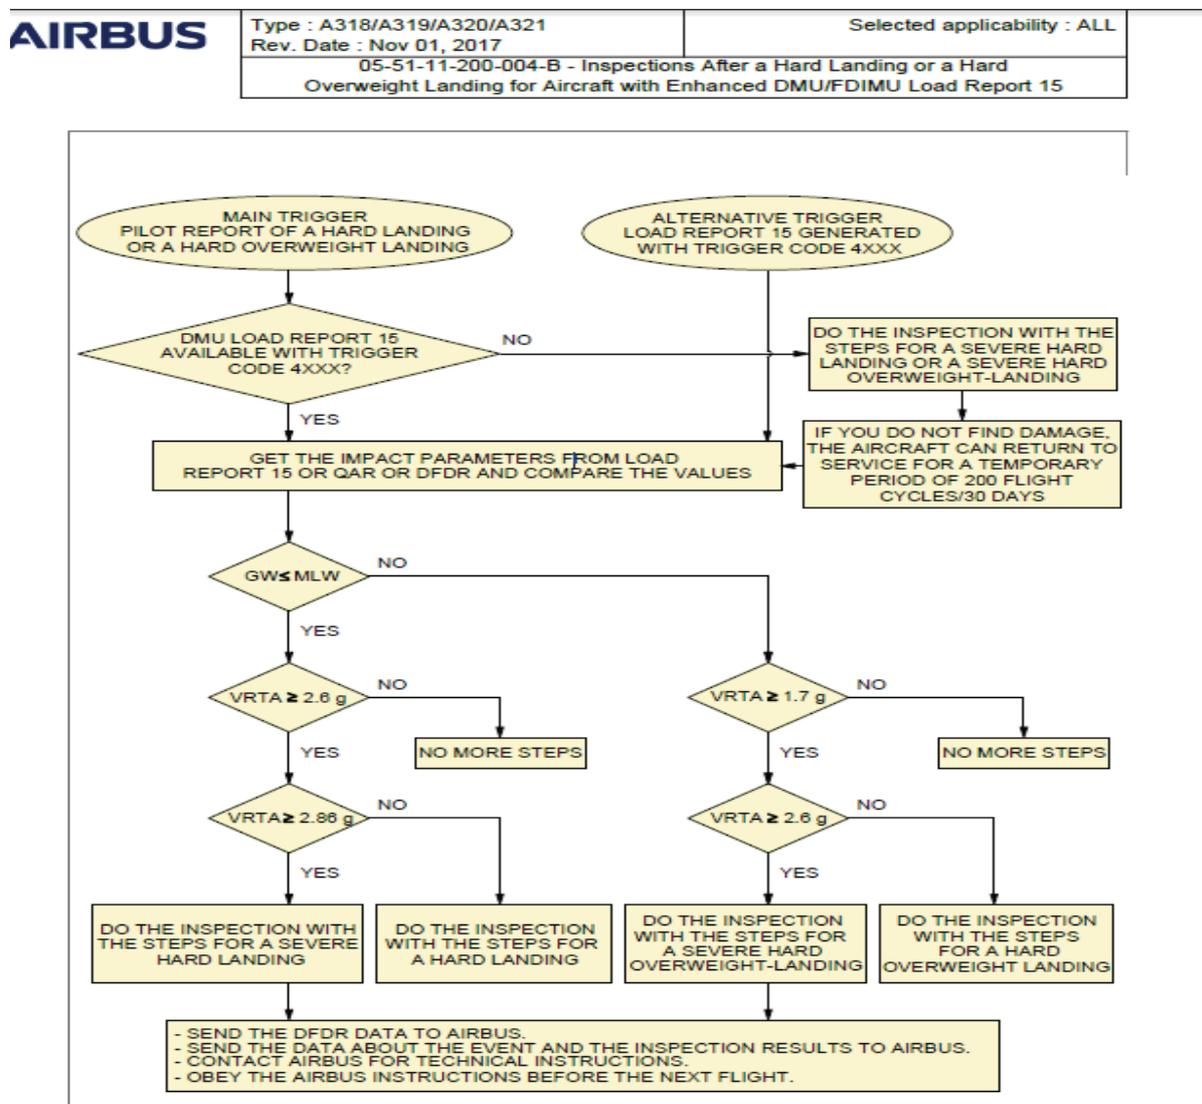
Slika 22: Grafikon inspekcije tvrdog sletanja

" nakon izveštaja posade o tvrdom/sletanju sa prekomernom težinom, morate potvrditi parametre uticaja da biste znali kategoriju sletanja. Da biste to saznali, pogledajte: - Izveštaj o opterećenju DMU-a 15 ili - pročitajte FDRS."

Posebne inspekcije sa koracima za tvrda sletanja moraju izvršiti inženjeri u vazduhoplovu nakon prekoračenja parametara.
